**High speed wind tests
on Ubbink Ubiflex
Flashing system.**

Prepared for: Barry Donaghue
of Ubbink uk Ltd

16th June 2008

Test report number 245-513

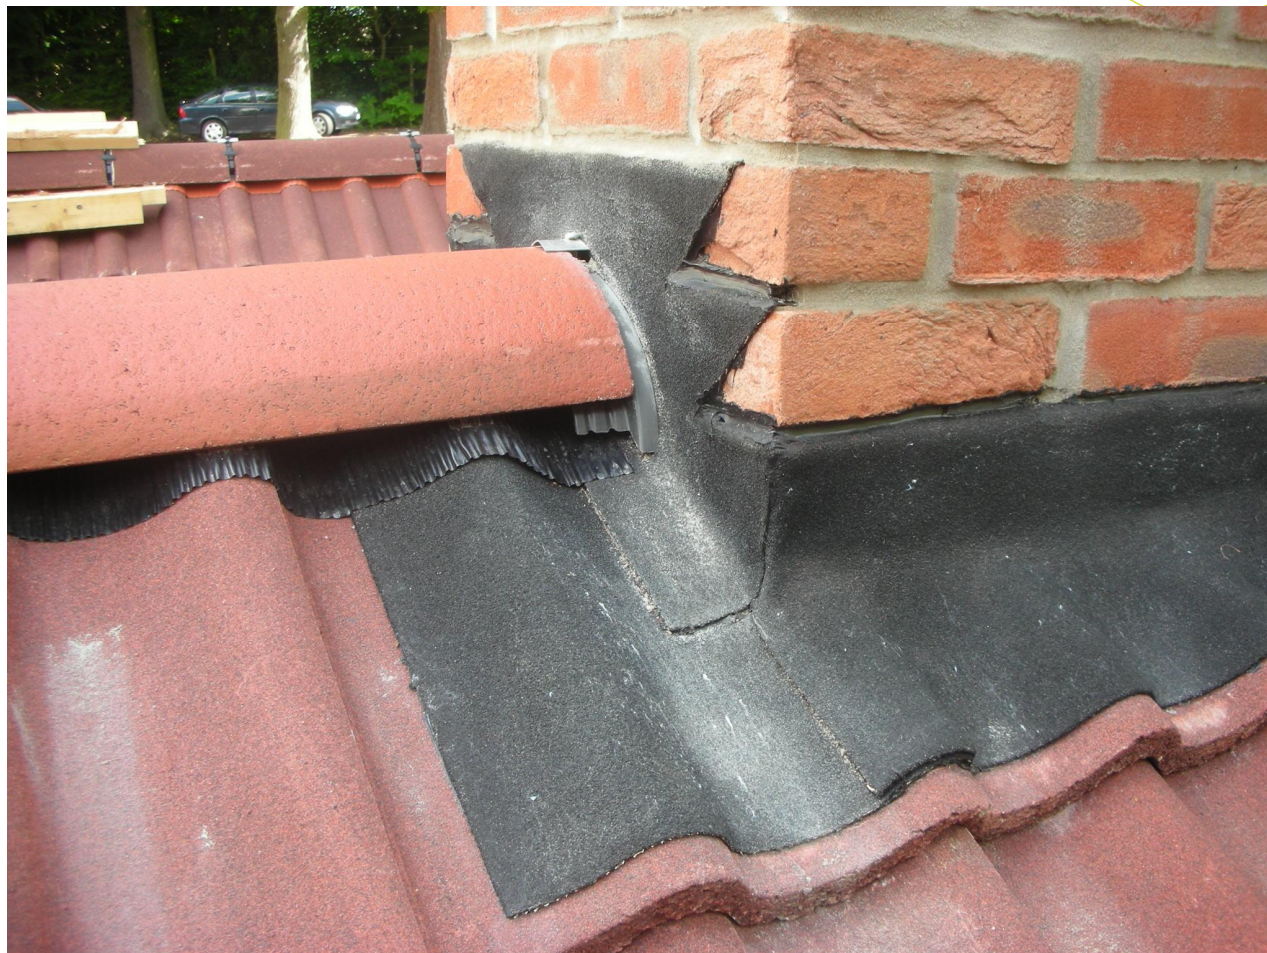
Figure 4 Side 1 showing detail of Ubbink Ventilated Dry Ridge system
